**CONTINUING ELIGIBILITY INSPECTION (CEI) REPORT
FOR HURRICANE/SHORE PROTECTION PROJECTS**

1. Project Name: Kekaha Shore Protection Project

2. Date of Inspection: 11 October 2002

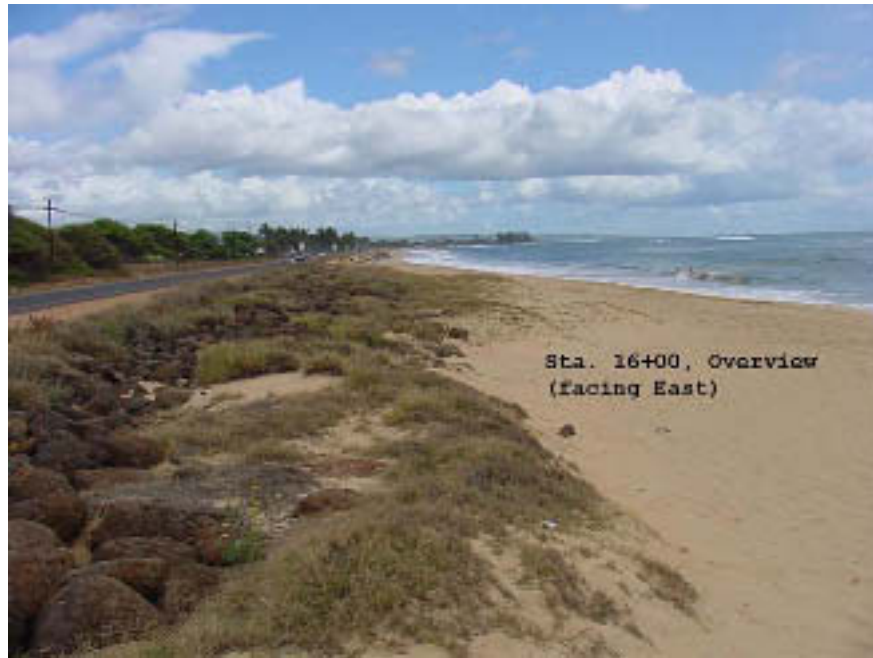
a. Sta. 16+00, Overview, revetment crest visible, note sand erosion.

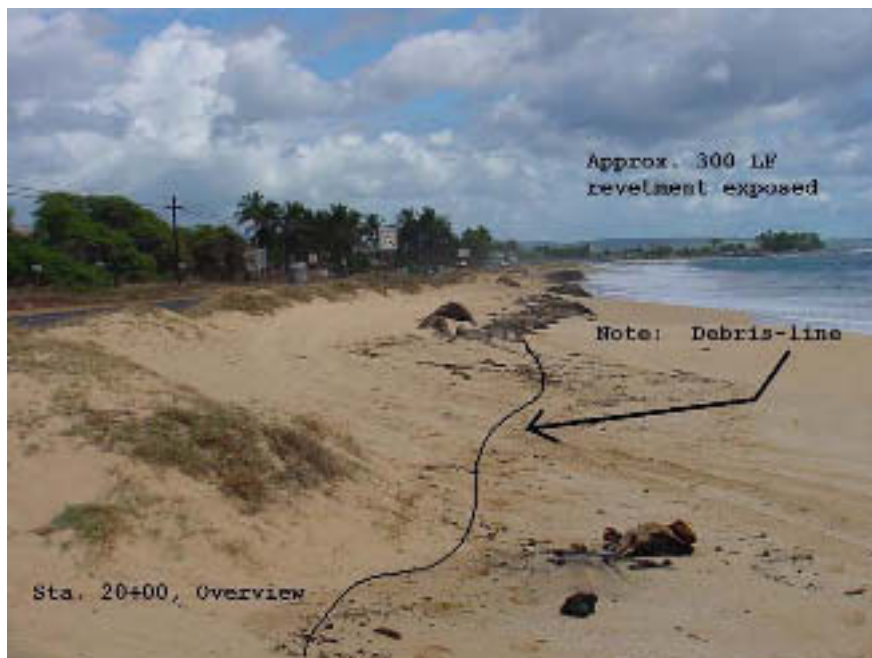
b. Sta. 20+00, Overview, revetment crest covered with sand, hinge visible, note sand erosion and debris line.

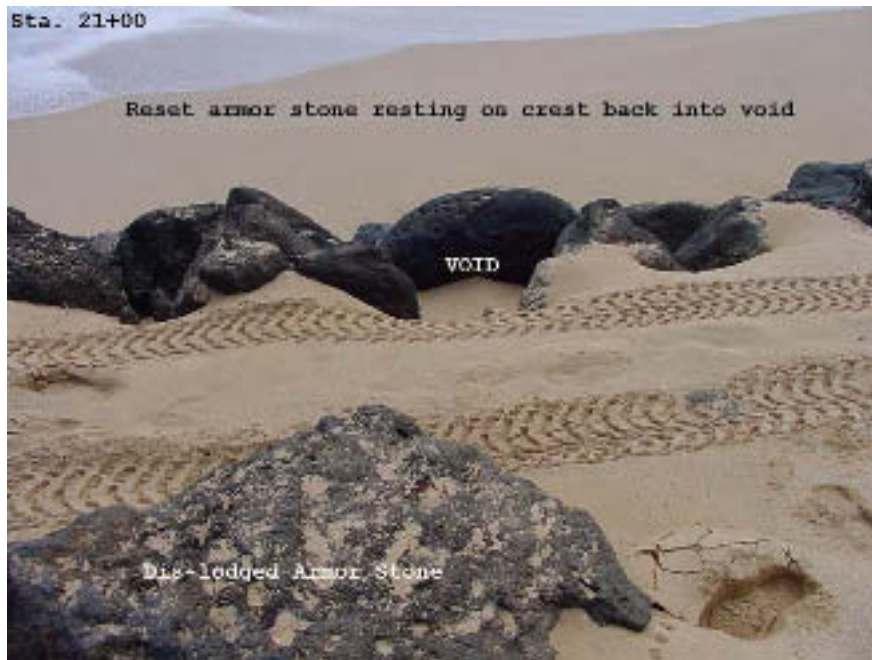
c. Sta. 21+00, Reset dislodged armor stone that is resting on the crest.

All deficiencies identified in last inspection have been corrected. The maintenance required on the project is primarily woody vegetation control and resetting one armor stone at Sta. 21+00₊. Vegetation control is excellent and no major deficiencies were noted.

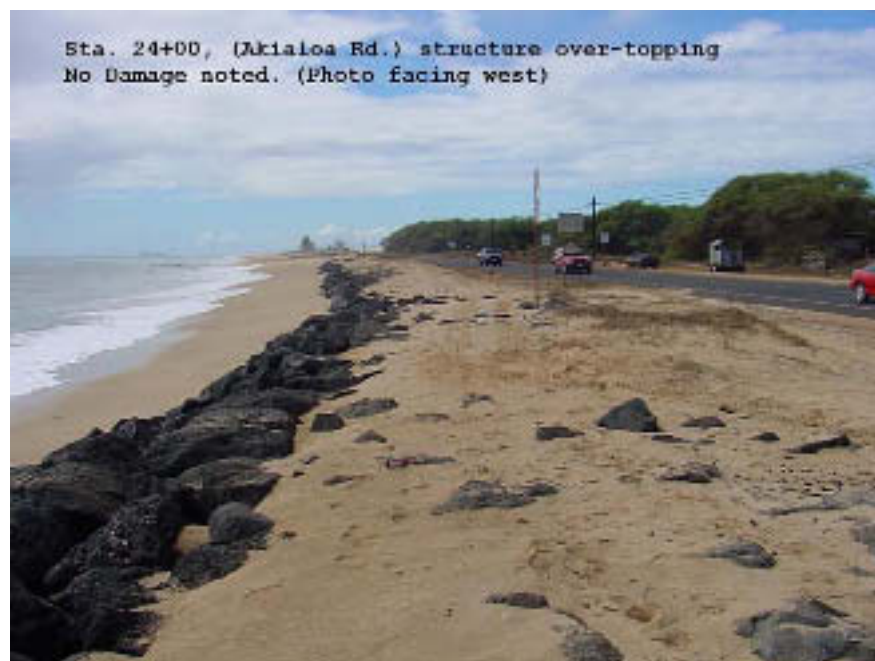
d. Sta. 24+00, Overview adjacent to Akialoa Rd. No damage to revetment, however there is evidence of overtopping.

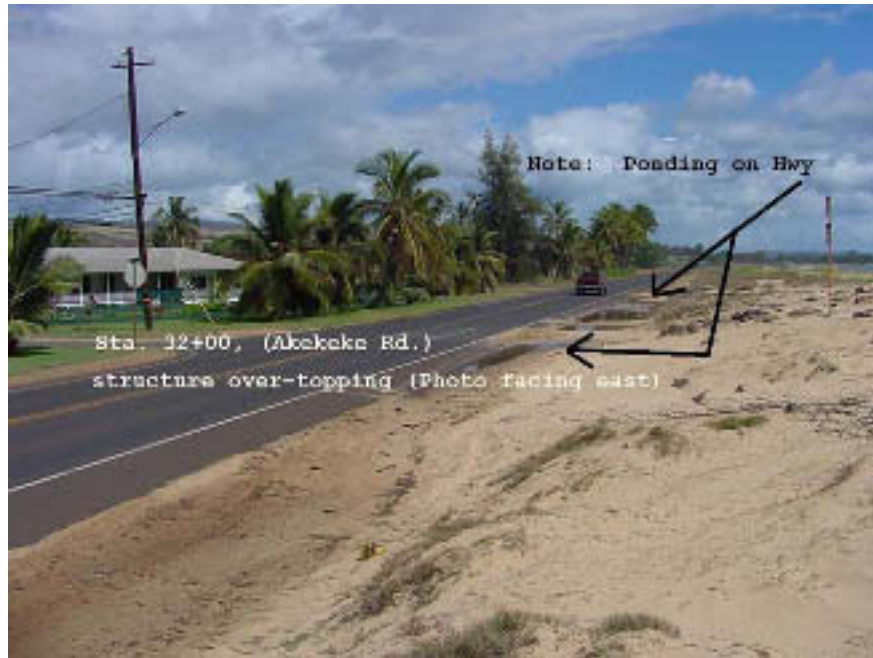
e. Sta. 32+00, Adjacent to Akekeke Rd. No damage to revetment, however there is evidence of overtopping.

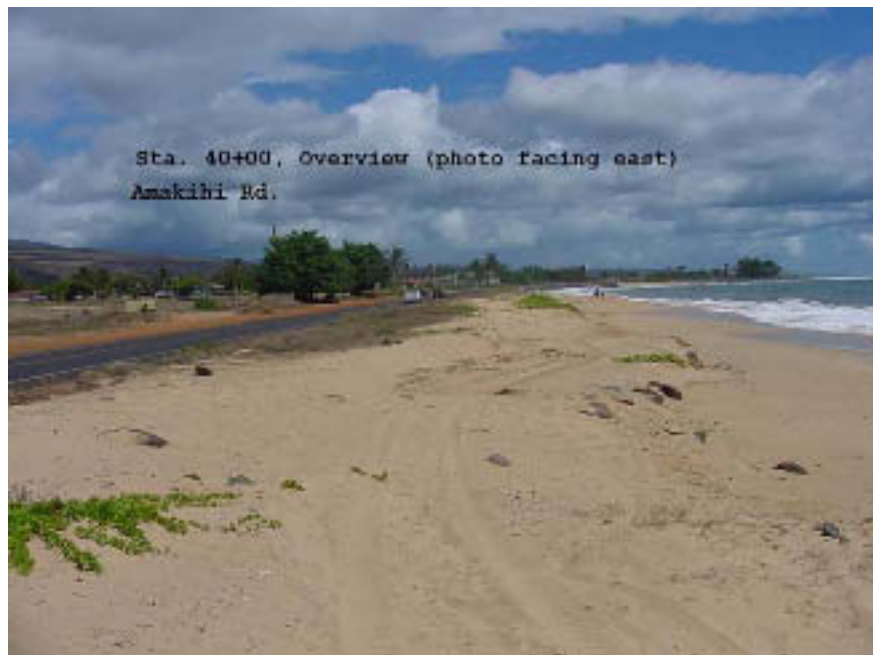
f. Sta. 40+00, Overview adjacent to Amakihi Rd.

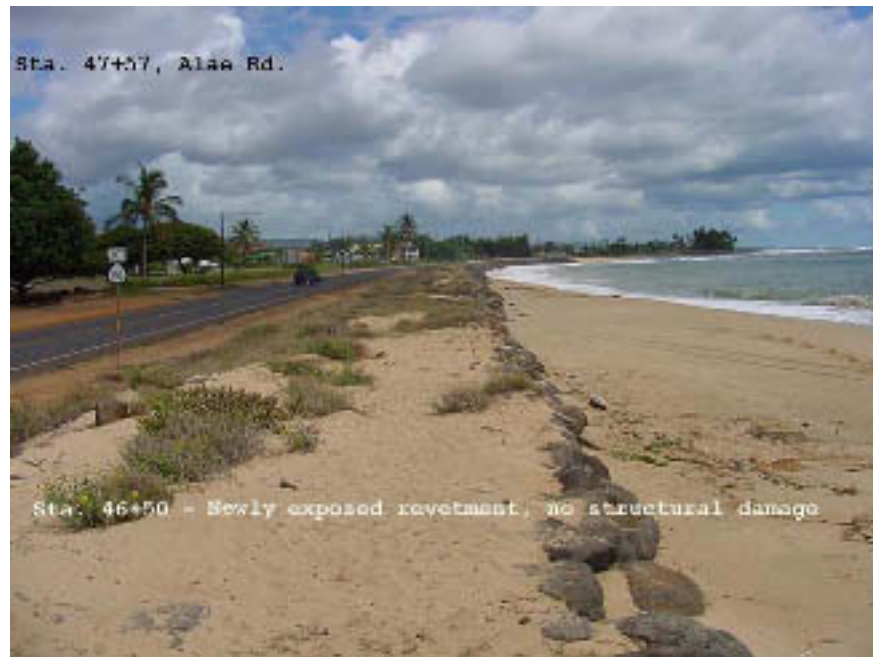
g. Sta. 46+50, Newly exposed revetment, no damages noted.

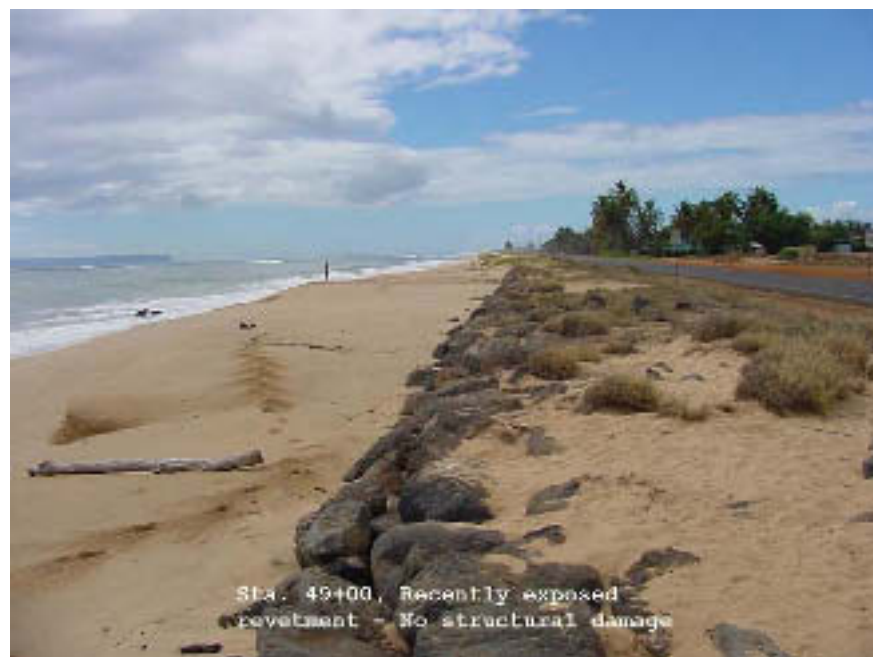
h. Sta. 49+00, Newly exposed revetment, no damages noted.

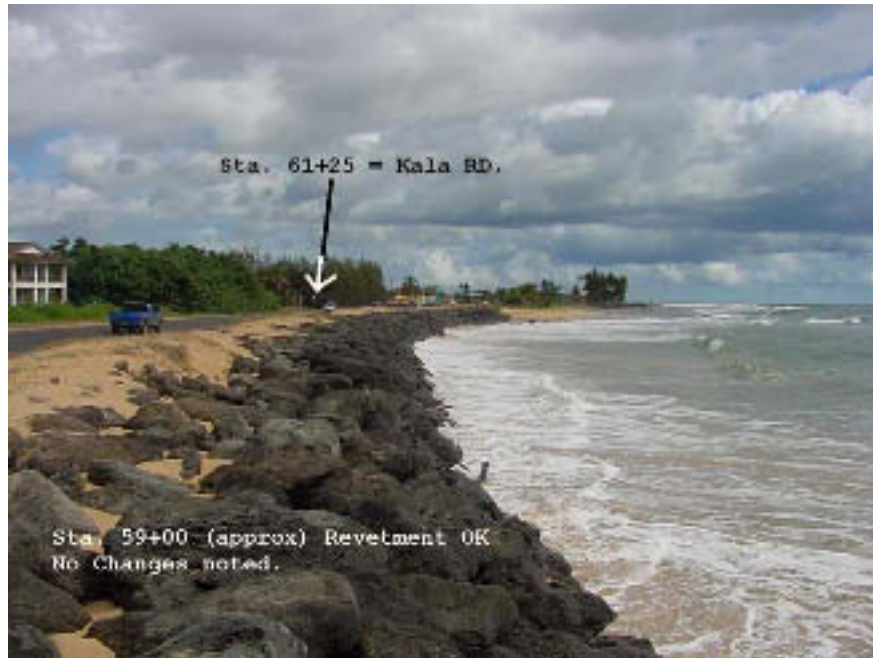
- i. Sta. 59+00, Revetment OK no changes noted.

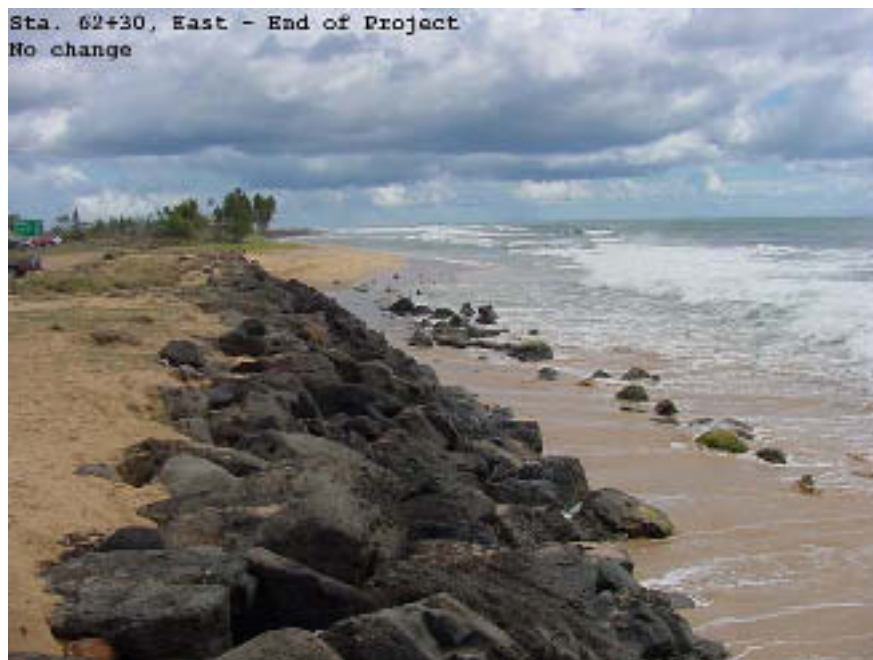
- j. Sta. 62+30, End of project, no changes noted, 500 lb. bedding layer exposed.
